# Guam Waterworks Authority (VP0989)

## CWA Collection System

Tumon, Guam

NEIC Field Investigation Photographs  
April 24 through May 4

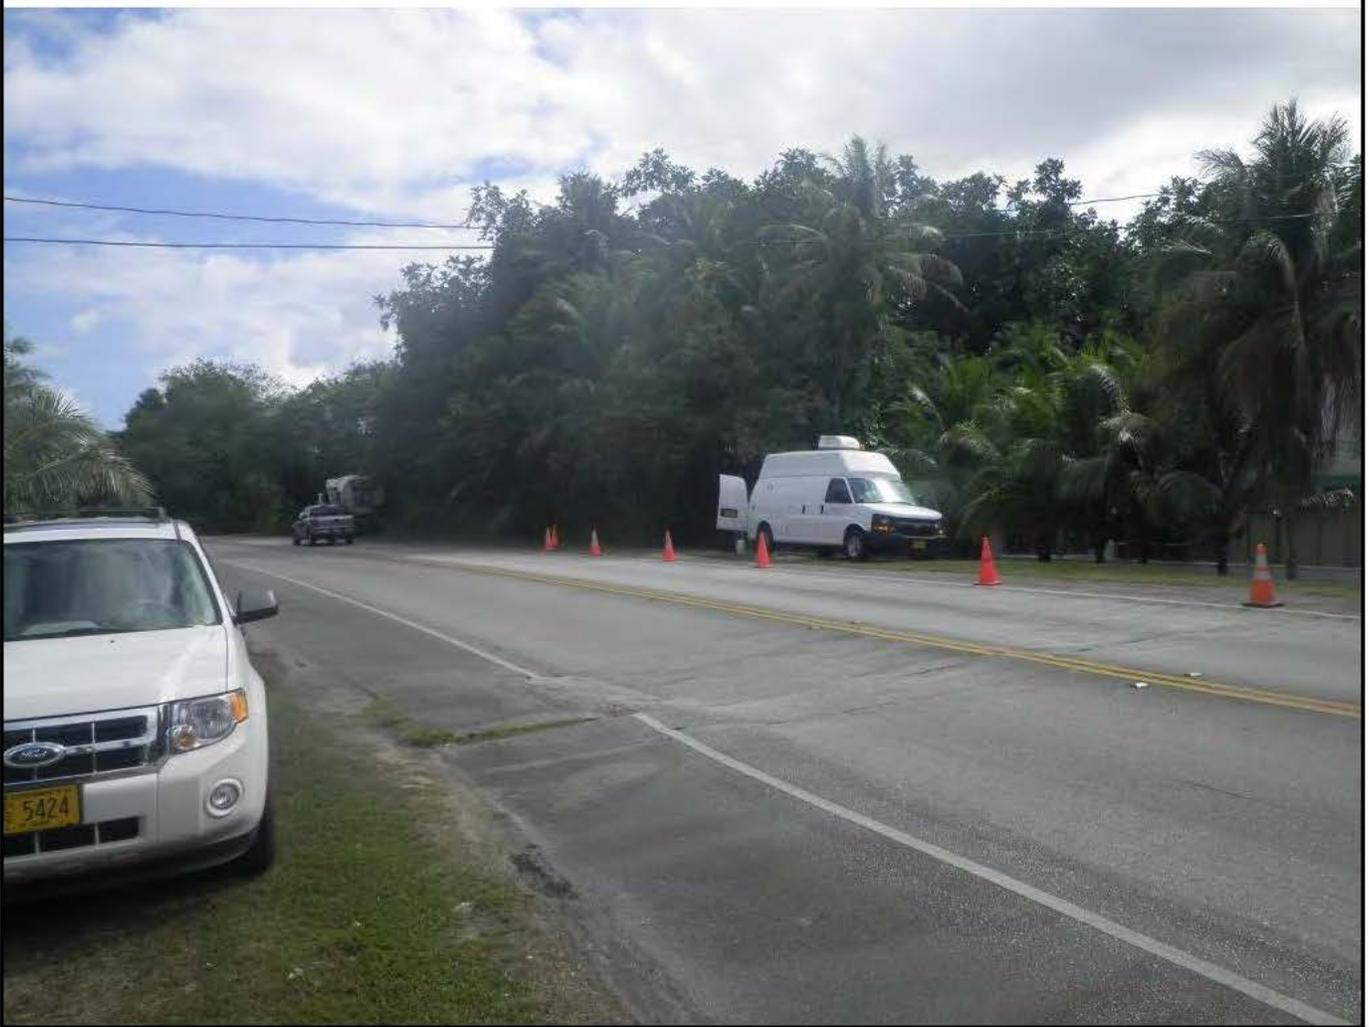
File Name: RIMG0135.JPG

Title	Guam Waterworks Authority (VP0989)
Subject	CWA Collection System
[REDACTED]	[REDACTED]
[REDACTED]	[REDACTED]
Date Time Stamp	5/2/2012 9:34:10 AM
Photographer	D. Vanlerberghe
Description	CCTV truck and cleaning crews along Route 2 near Agat.

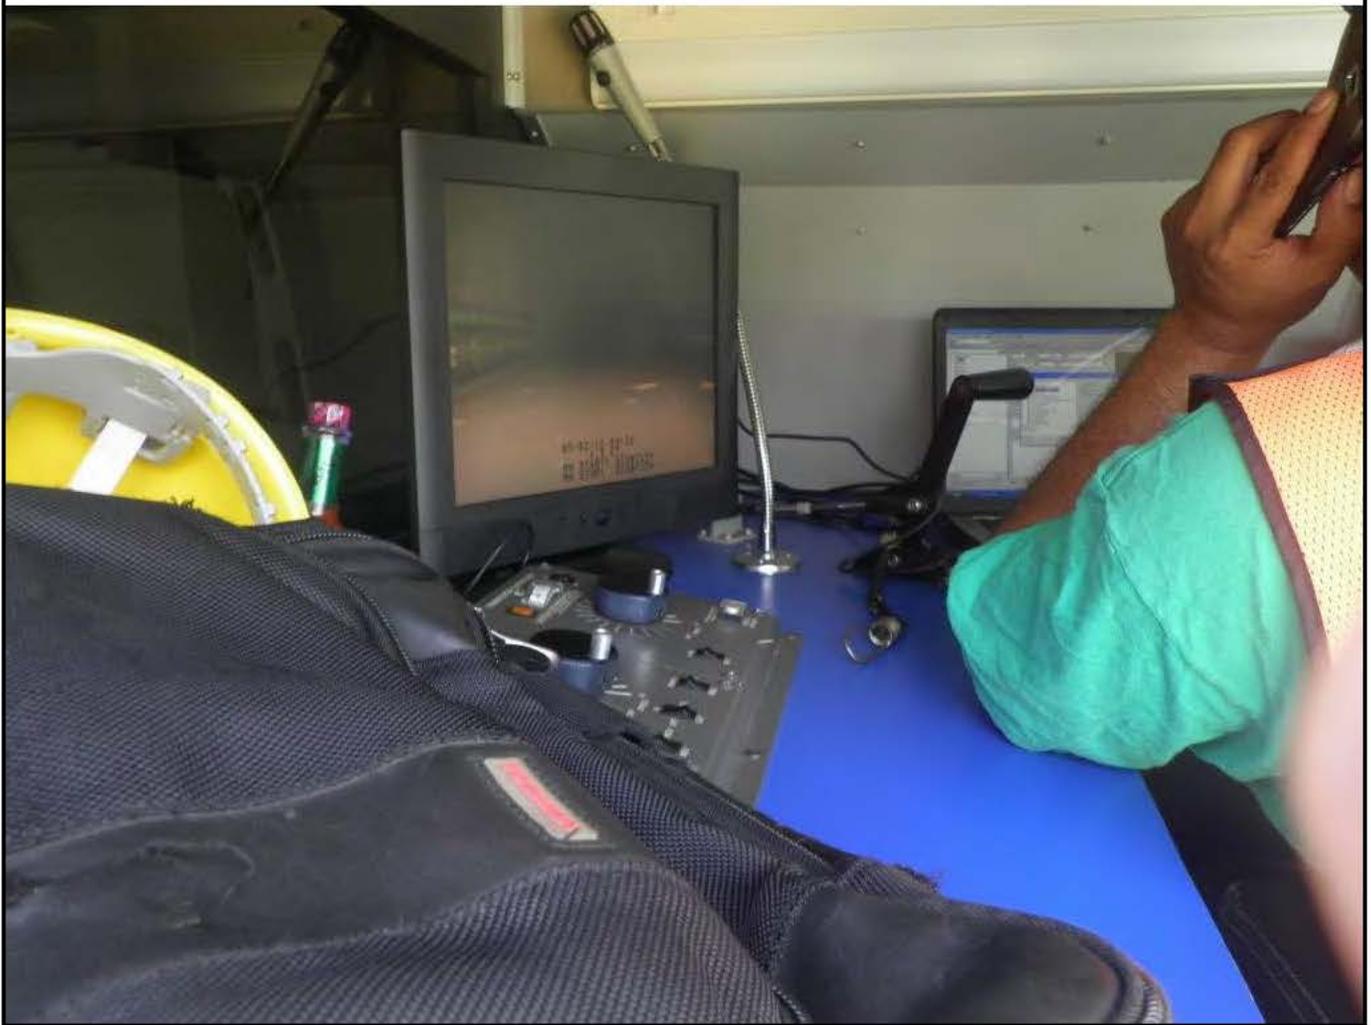
File Name: RIMG0136.JPG

Title	Guam Waterworks Authority (VP0989)
Subject	CWA Collection System
Date Time Stamp	5/2/2012 9:54:31 AM
Photographer	D. Vanlerberghe
Description	Inside CCTV truck.

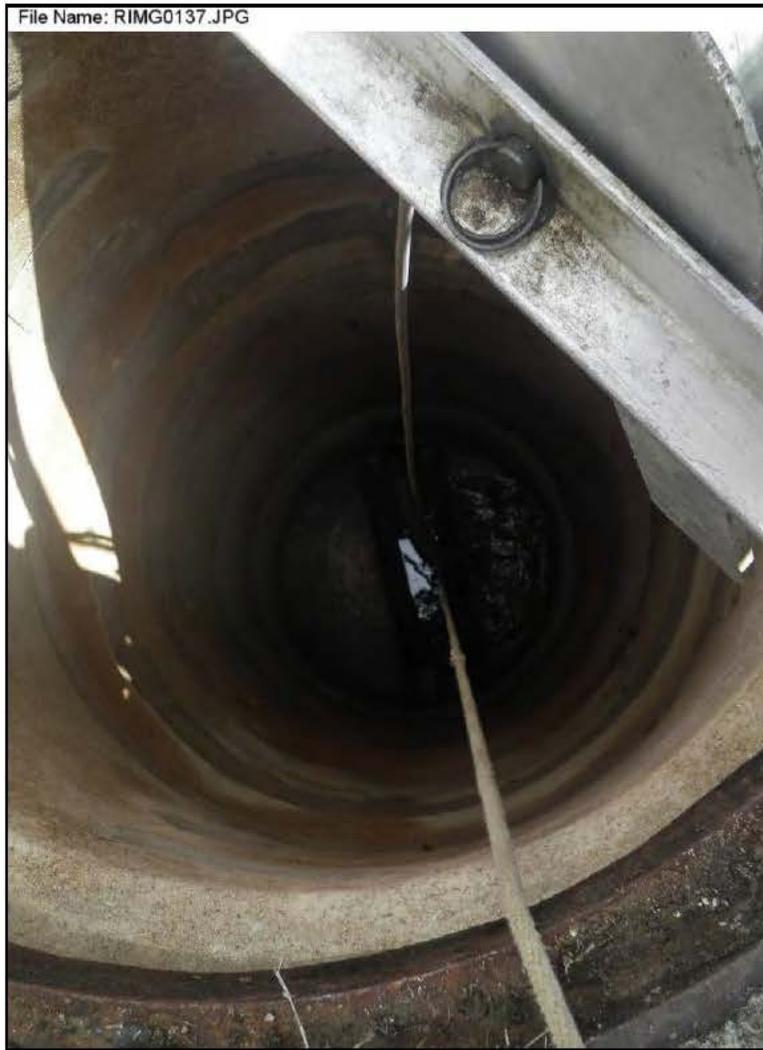
Attributes	
Title	
Subject	
Date Time Stamp	5/2/2012 9:55:43 AM
Photographer	D. Vanlerberghe
Description	Manhole set up with CCTV camera.

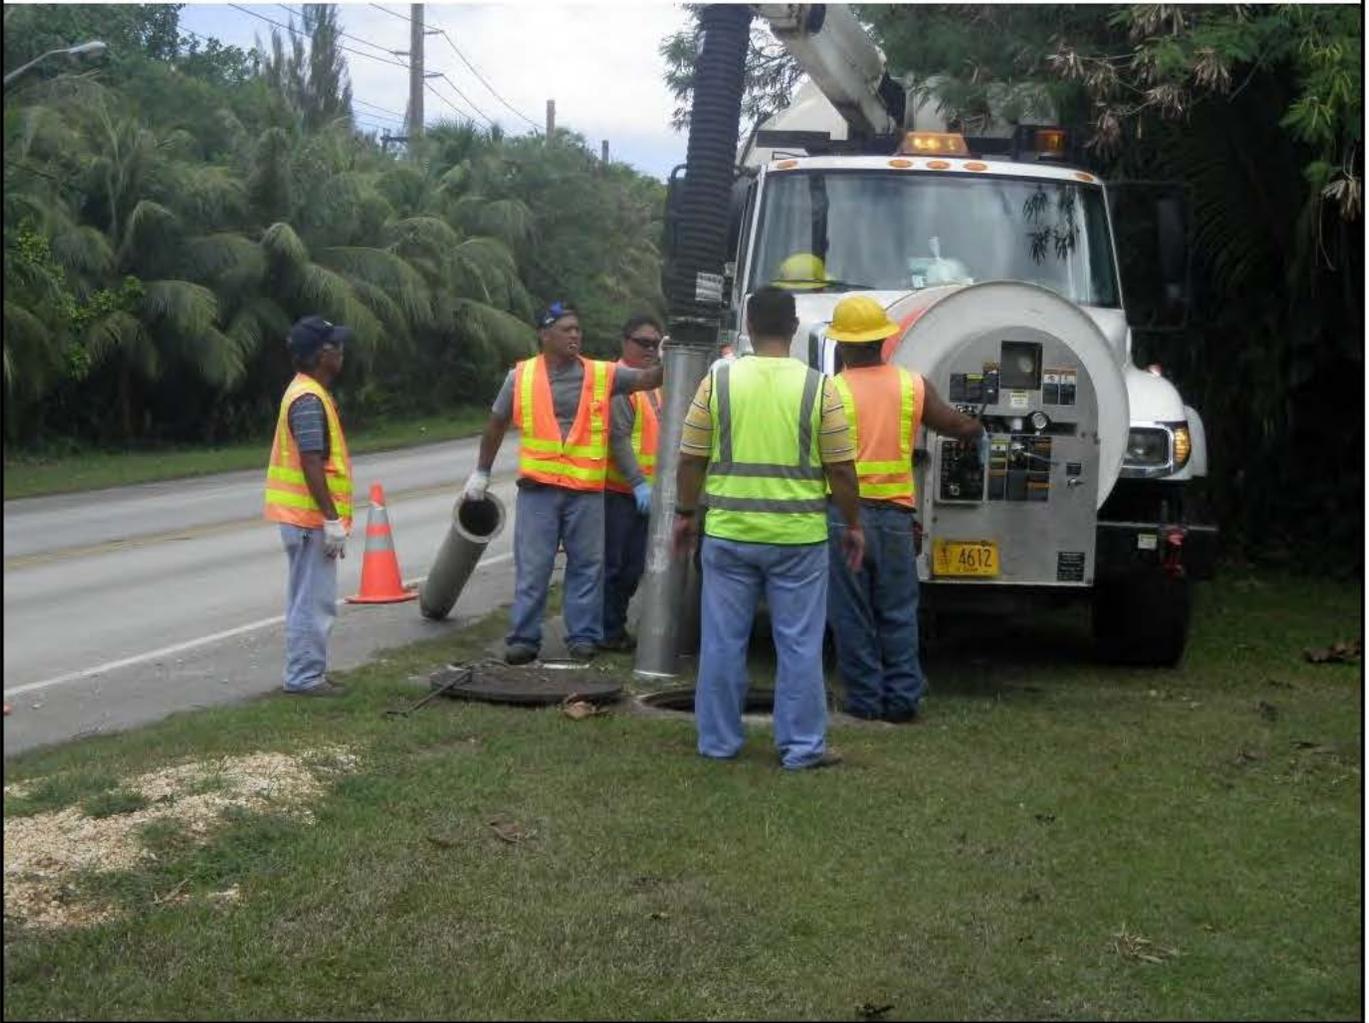
File Name: RIMG0140.JPG

Title	Guam Waterworks Authority (VP0989)
Subject	CWA Collection System
Date Time Stamp	5/2/2012 10:19:32 AM
Photographer	D. Vanlerberghe
Description	Sewer cleaning crew set-up, cleaning sewer line prior to CCTV televising of sewer line.

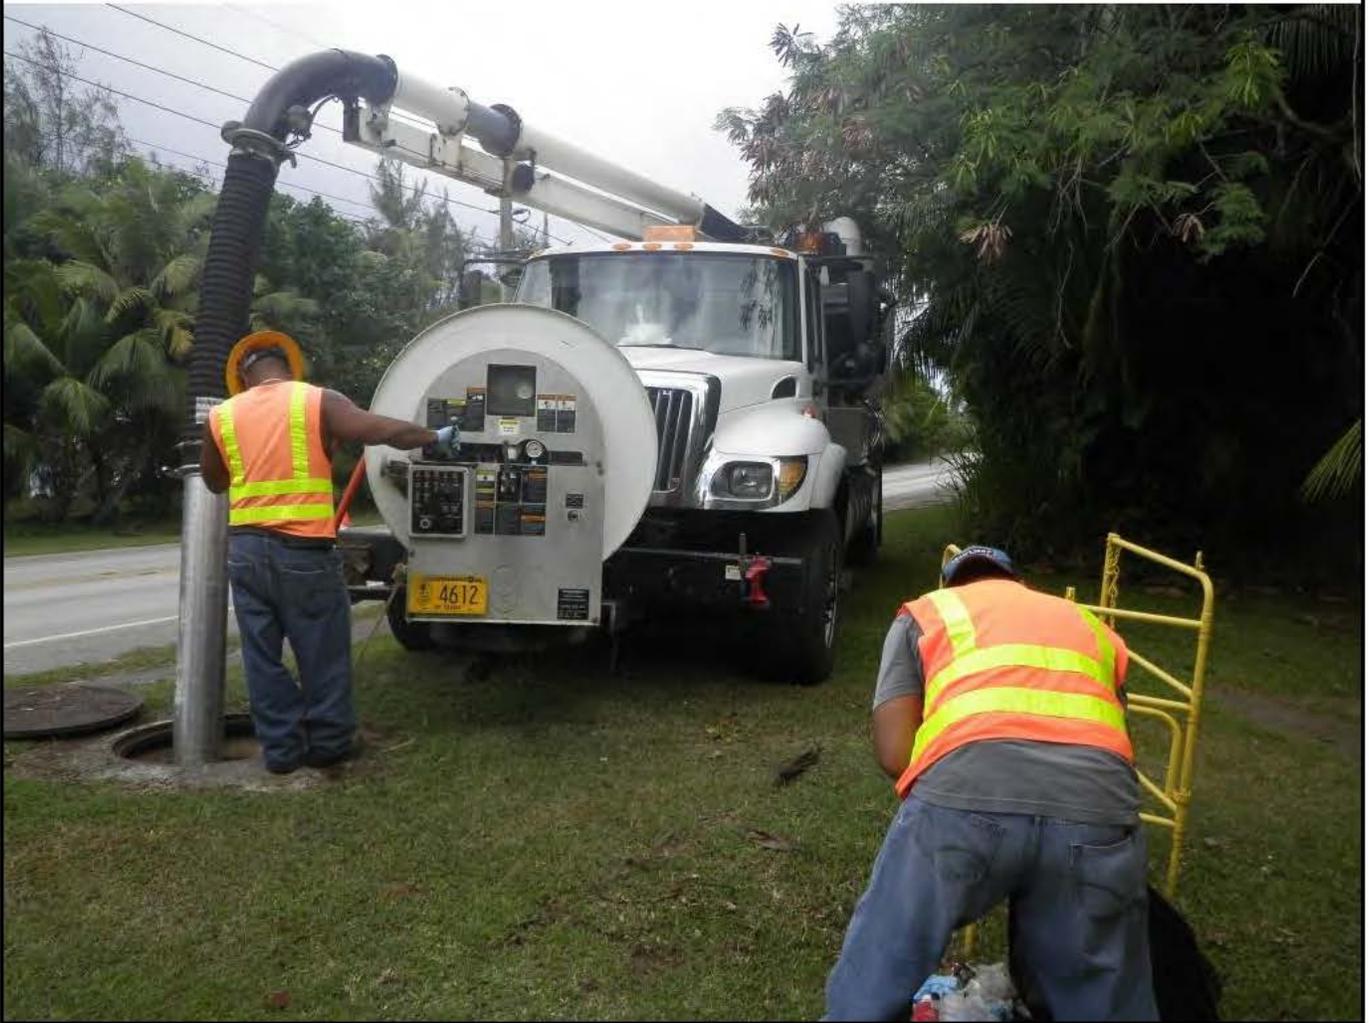
File Name: RIMG0141.JPG

Title	Guam Waterworks Authority (VP0989)
Subject	CWA Collection System
Date Time Stamp	5/2/2012 10:22:30 AM
Photographer	D. Vanlerberghe
Description	Combination vacator/jetter sewer cleaning truck.

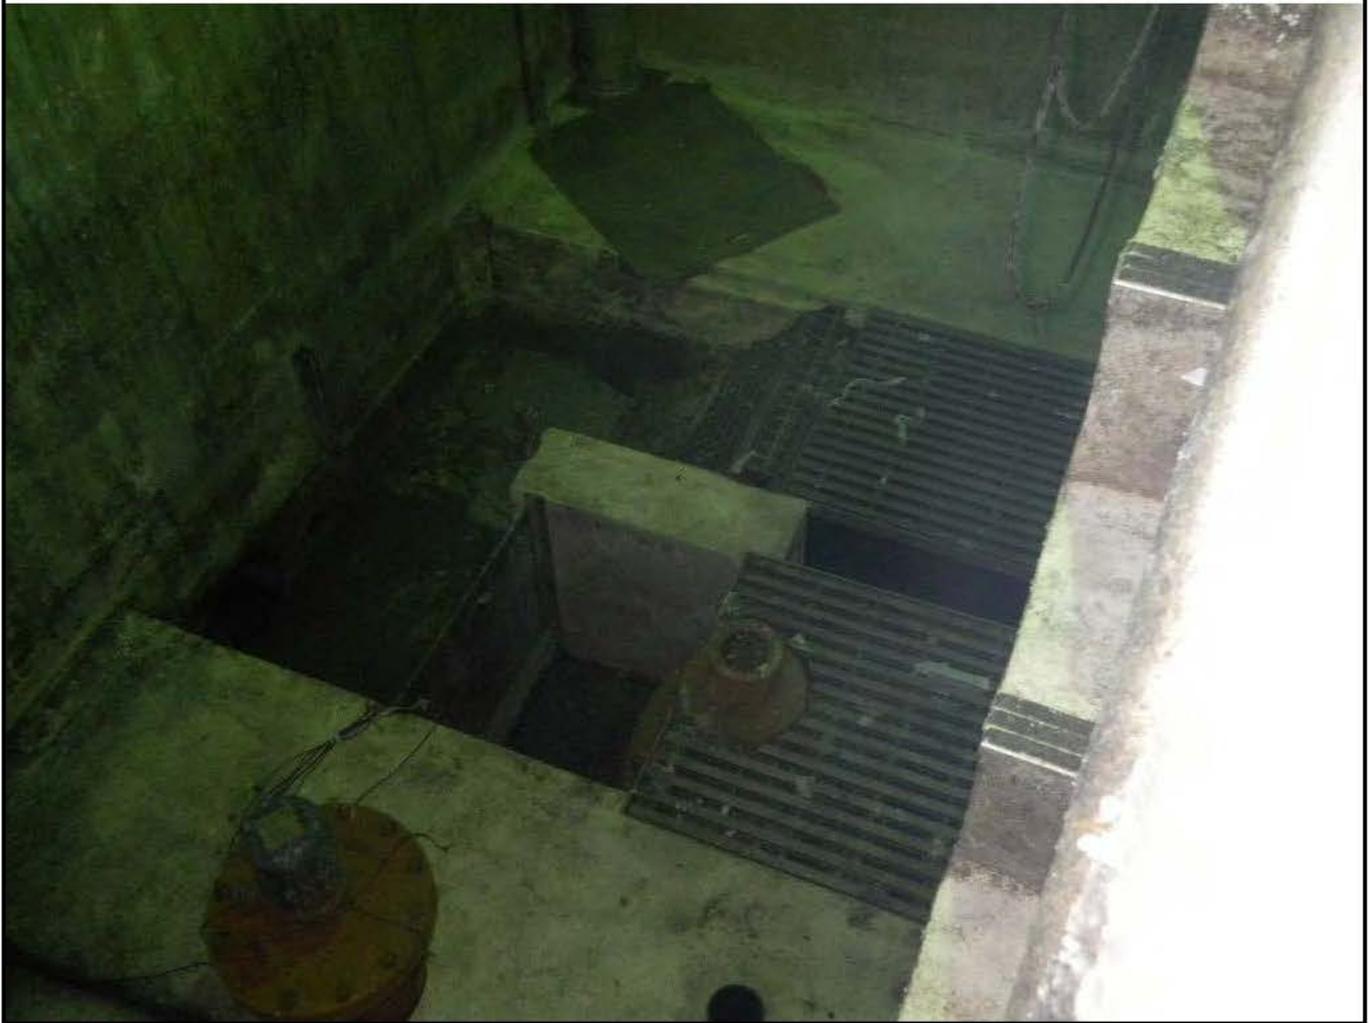
File Name: RIMG0143.JPG

Title	Guam Waterworks Authority (VP0989)
Subject	CWA Collection System
Date Time Stamp	5/3/2012 10:47:29 AM
Photographer	D. Vanlerberghe
Description	Talafofo pump station wet well.

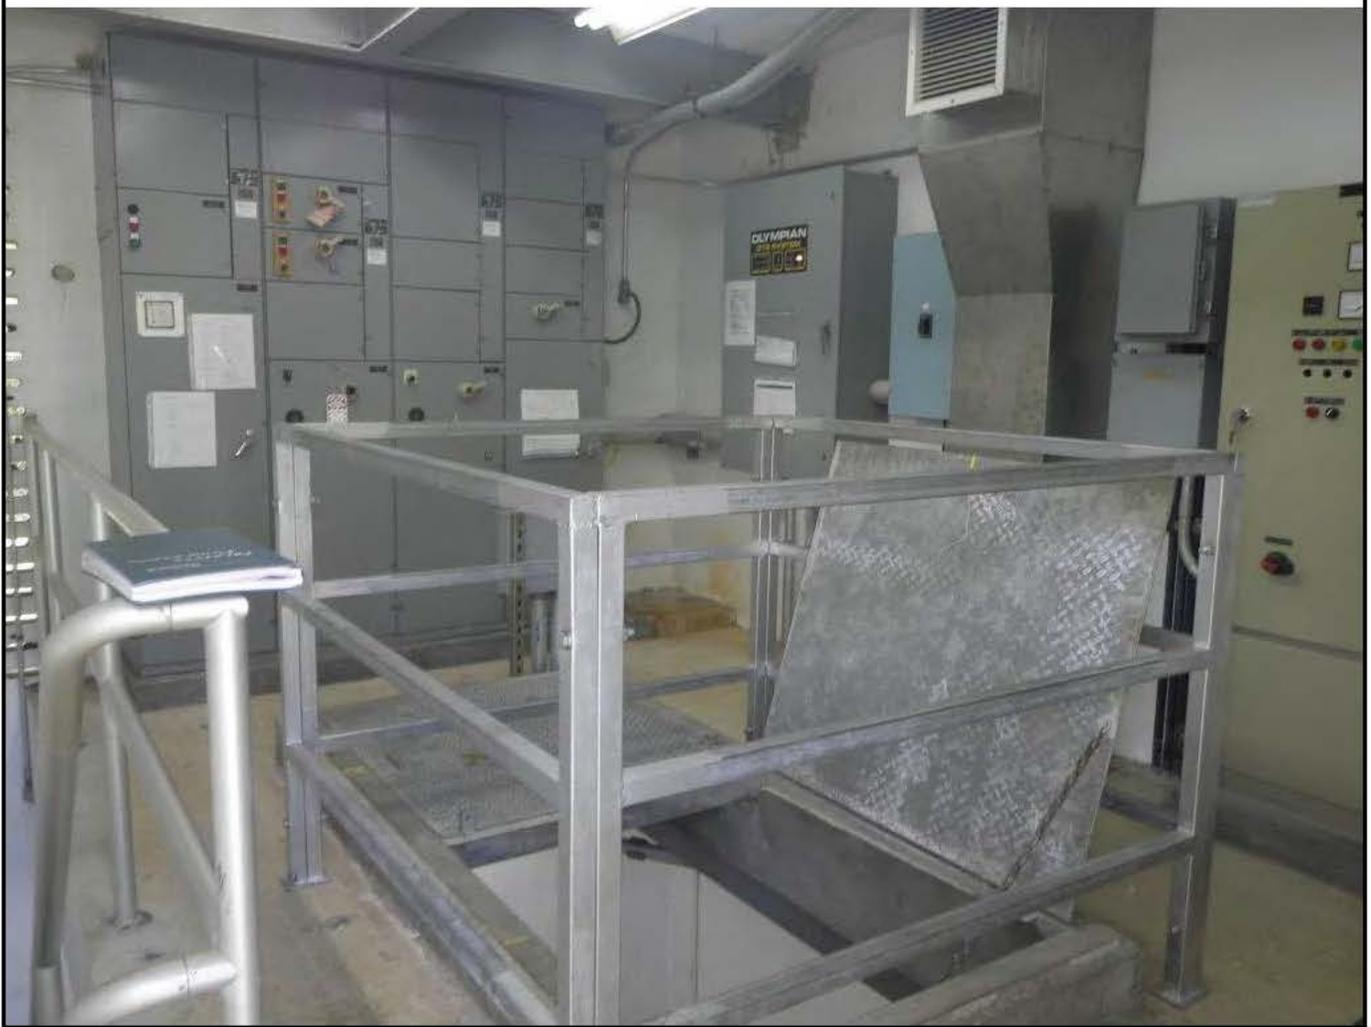
File Name: RIMG0144.JPG

Title	Guam Waterworks Authority (VP0989)
Subject	CWA Collection System
Date Time Stamp	5/3/2012 10:49:07 AM
Photographer	D. Vanlerberghe
Description	Talafofo pump station control room.

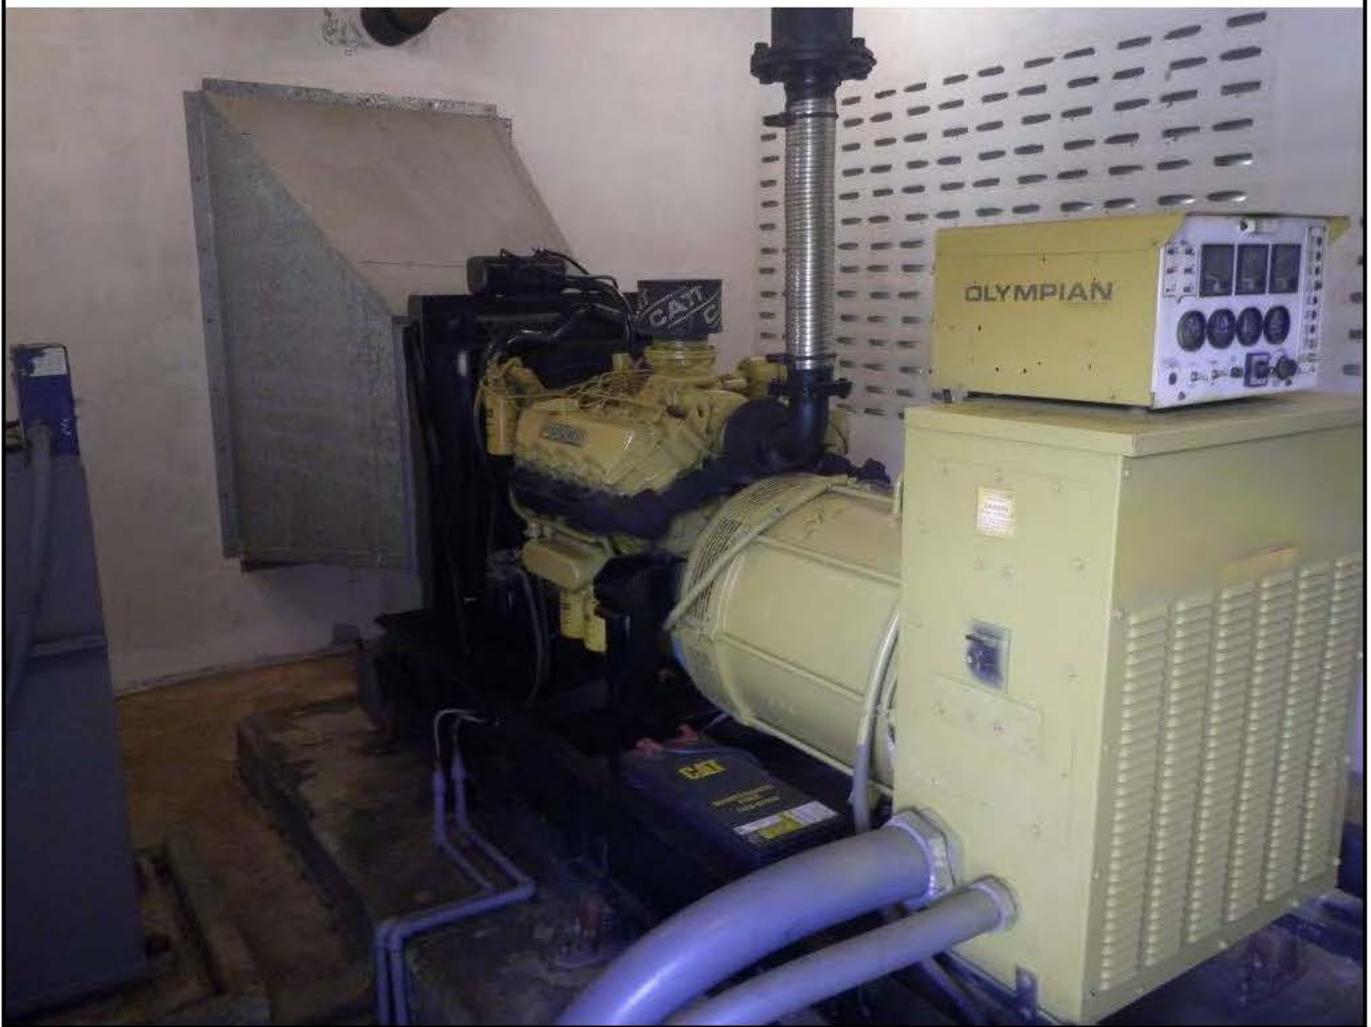
File Name: RIMG0145.JPG

Title	Guam Waterworks Authority (VP0989)
Subject	CWA Collection System
Photographer	D. Vanlerberghe
Description	Talafofo pump station standby generator.

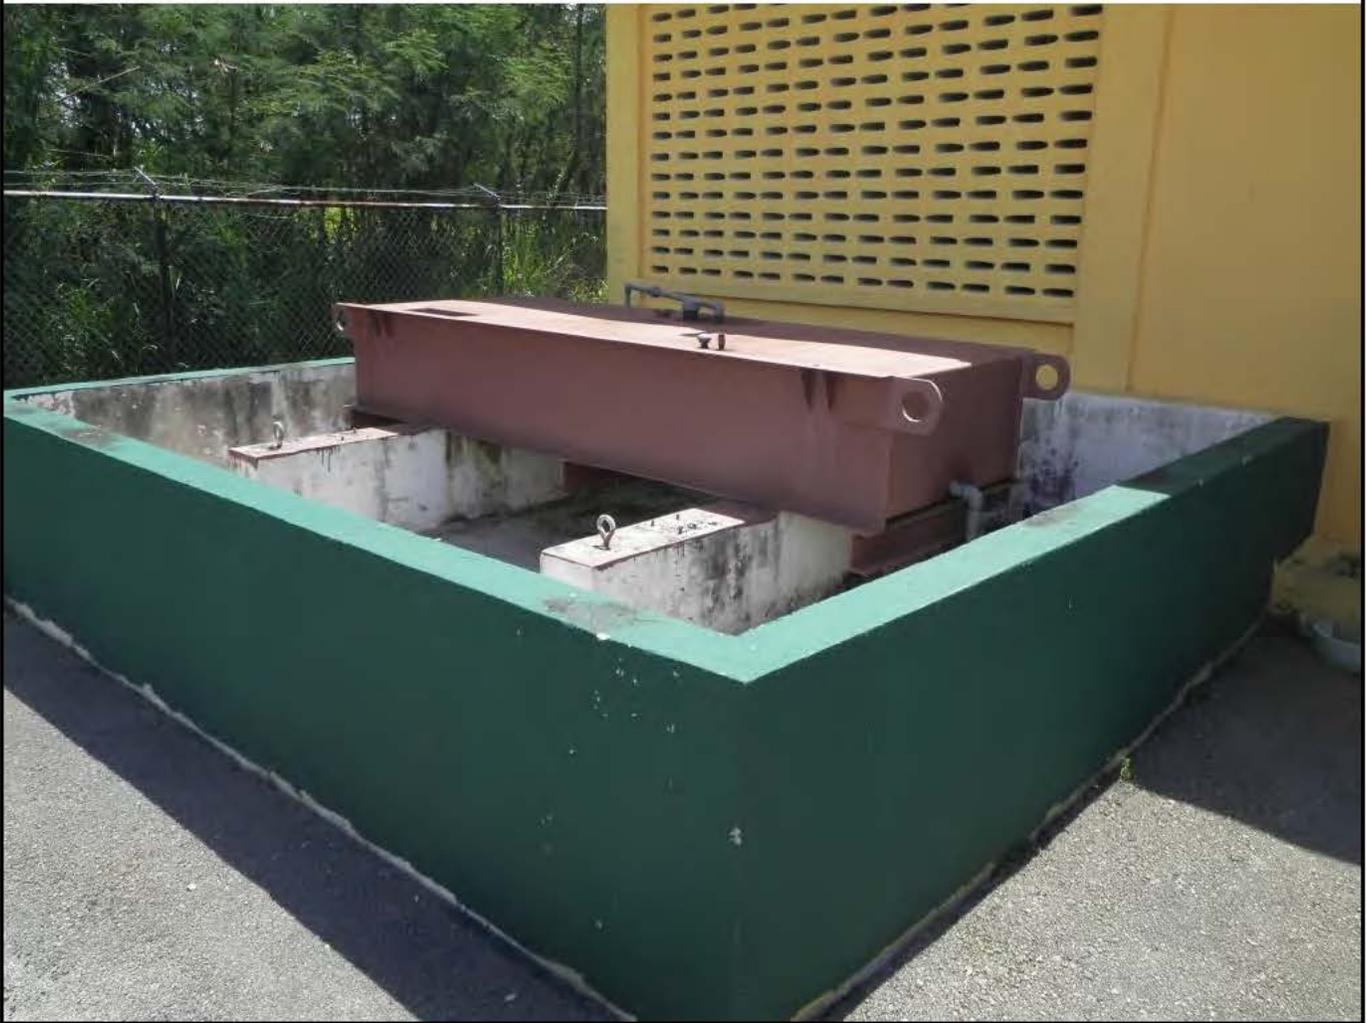
File Name: RIMG0146.JPG

Title	Guam Waterworks Authority (VP0989)
Subject	CWA Collection System
Date Time Stamp	5/3/2012 10:55:38 AM
Photographer	D. Vanlerberghe
Description	Talafofo pump station fuel tank.

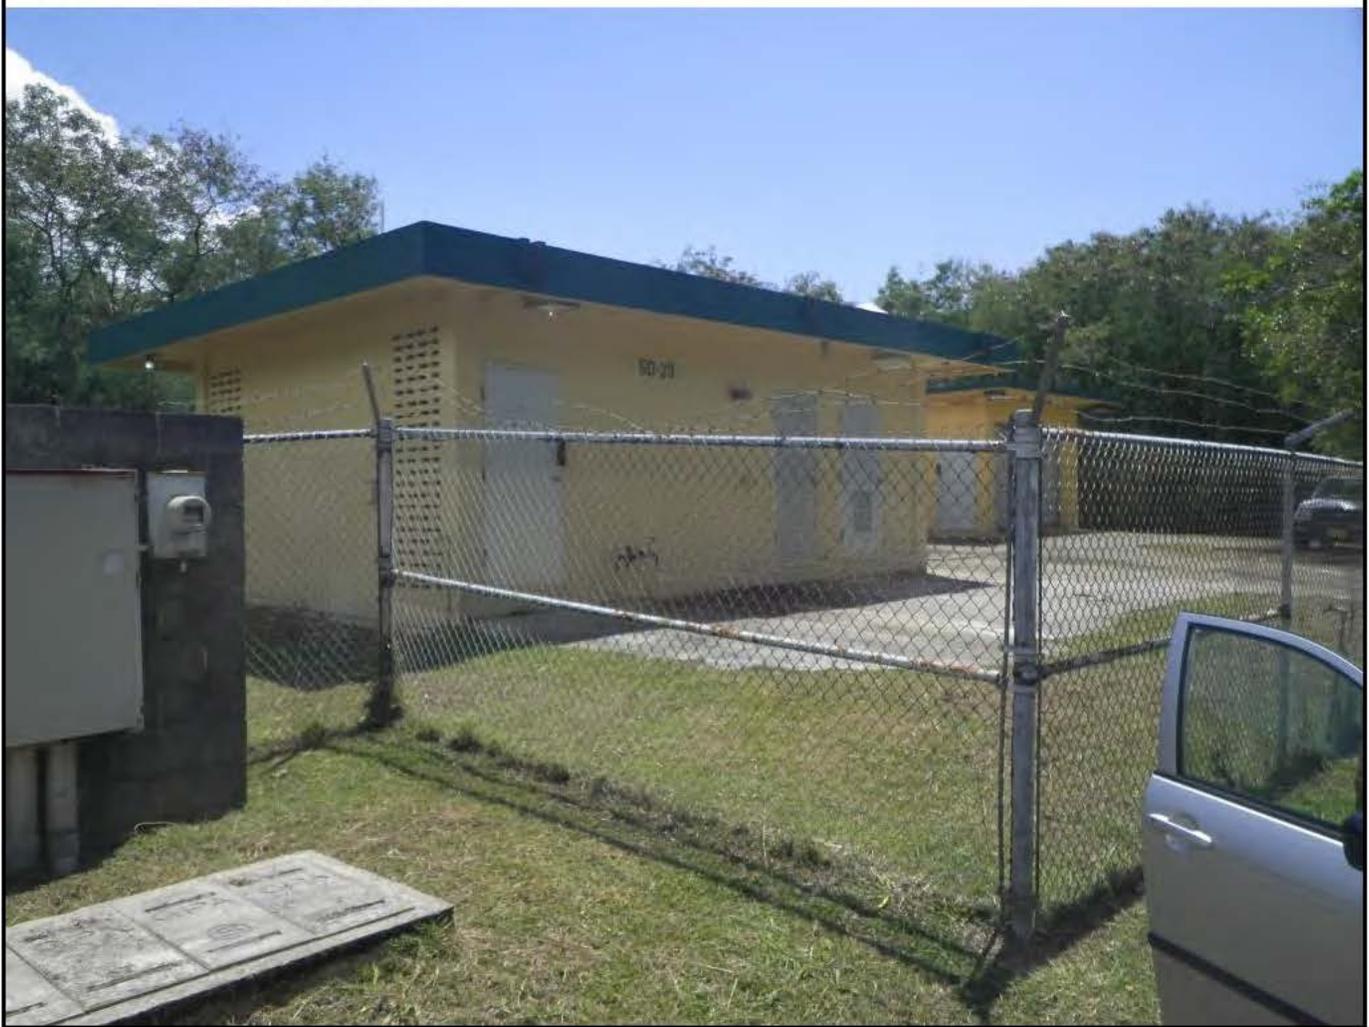
File Name: RIMG0147.JPG

Title	Guam Waterworks Authority (VP0989)
Subject	CWA Collection System
Date Time Stamp	5/3/2012 10:59:52 AM
Photographer	D. Vanlerberghe
Description	Talafofo pump station building.
